QA of RIP-RAP Placement Using Scanning Sonar

Data collection: **Nautilus Marine Group** (Lansing, Michigan) & **Kongsberg Mesotech Ltd.**

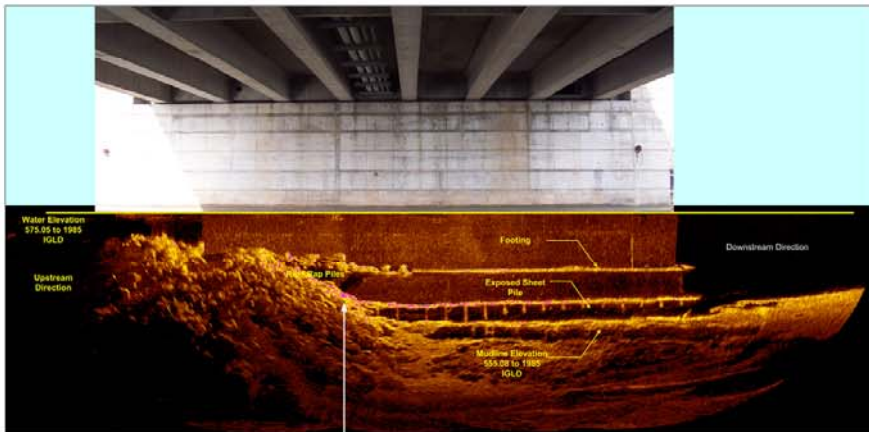
Vertical Visualization East Side View of Pier

Rip-Rap Countermeasures was designed for 100-year flood event and to be placed no higher than top of footing elevation, and at a 1 to 3 slope out from footing.

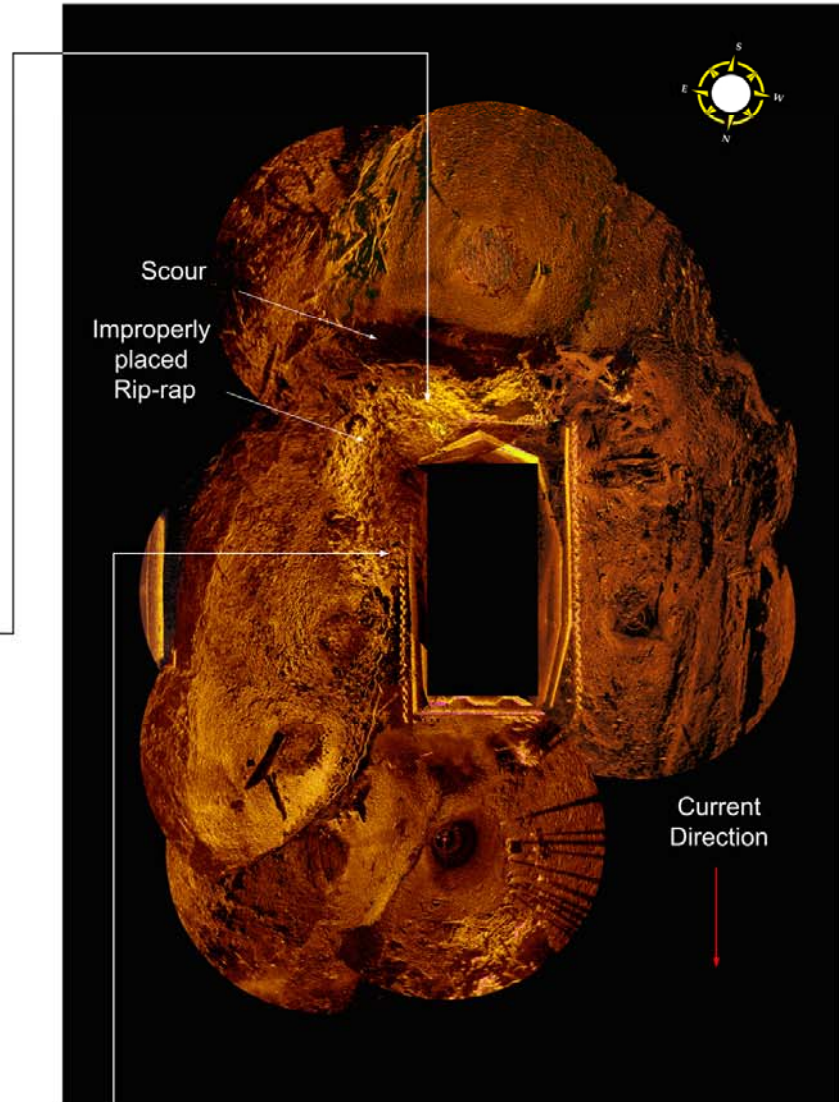
Bridge Pier Plan View and River bed Mosaic

Improper placement of rip-rap increases the potential for further scour.
